Project Profile

Project: Esholt WWTW FFD Tank Repairs

Client: Yorkshire Water PLC

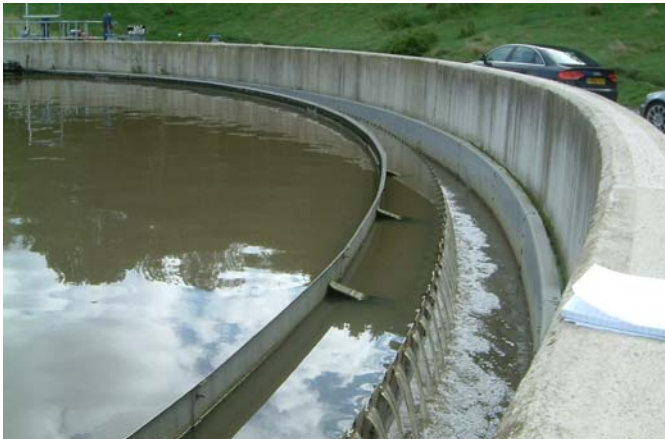
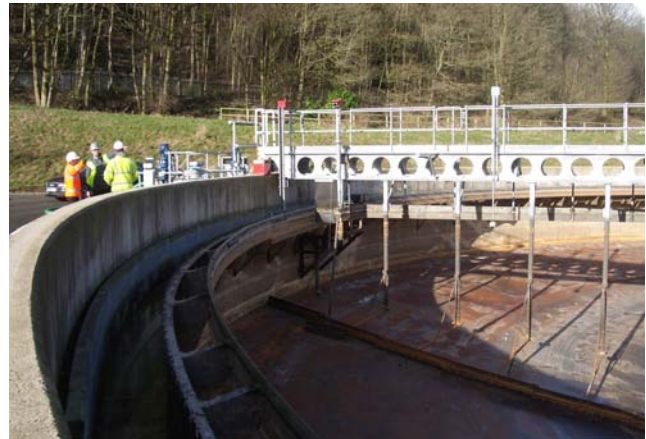
Both settlement tanks were showing signs of wear, particularly the tops and sides of walls where the concrete was friable and had broken down at the surface to leave an exposed aggregate finish, as opposed to the original smooth surface finish desired by the client. Maintaining the original profile on the tops of the walls was of great importance due to the contact that they are subjected from the wheel of sludge agitator boom, which constantly runs directly over the wall tops, around each tank's circumference.

APA Concrete Repairs Ltd delivered a programme of restoration and protection that involved the installation of fixed scaffolding platforms inside each tank after which they prepared the walls using wet abrasive blasting, before applying a specialist re-profiling mortar and subsequently a protective coating system in order to maintain the service life of the tanks and reduce future 'life cycle' maintenance costs.
