Project Profile: Wimbledon Athletic Stand

Project: Wimbledon Athletic Stand, Concrete Repairs

Client: Merton London Borough Council

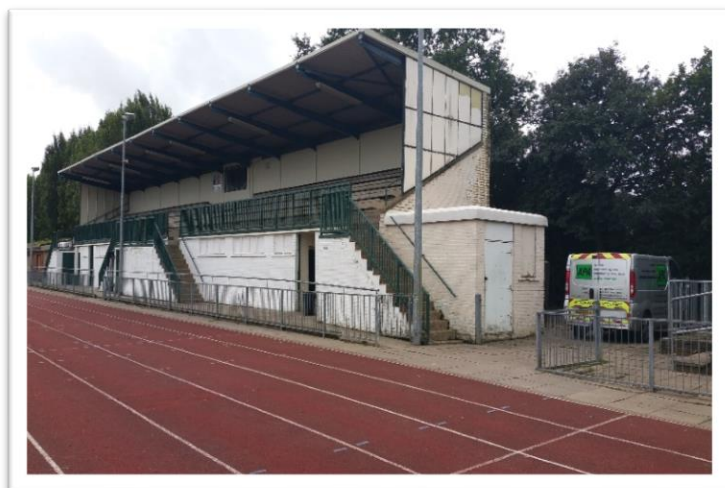
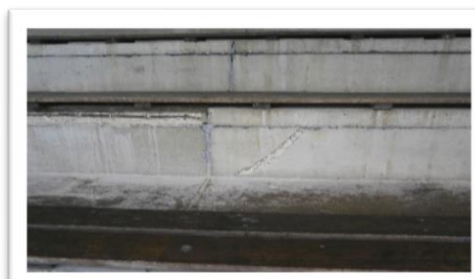
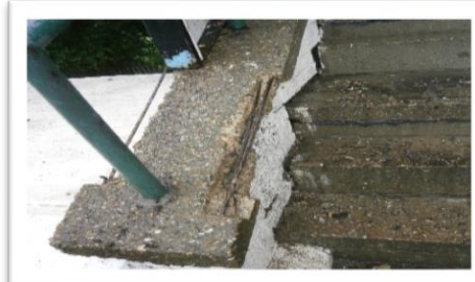
The project: Wimbledon Athletic running track stand required a series of repair works in 2015, due to various concrete defects situated on several staircases which run through the stands. **APA Concrete Repairs Ltd** were appointed to undertake a series of surveys and testing, followed by a programme of repair works, to specified areas of the athletic stand.

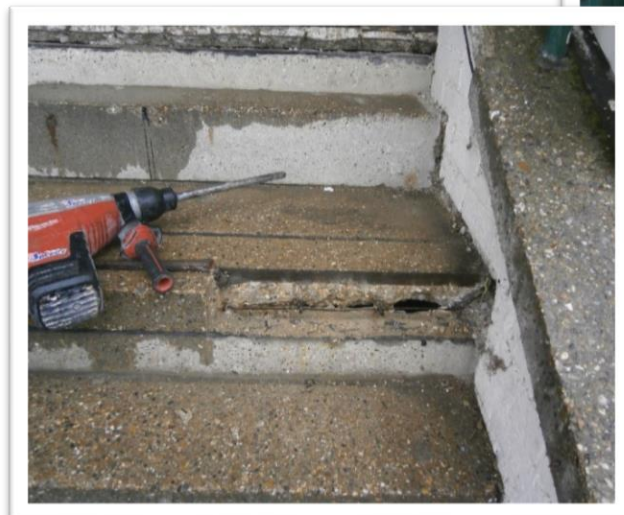
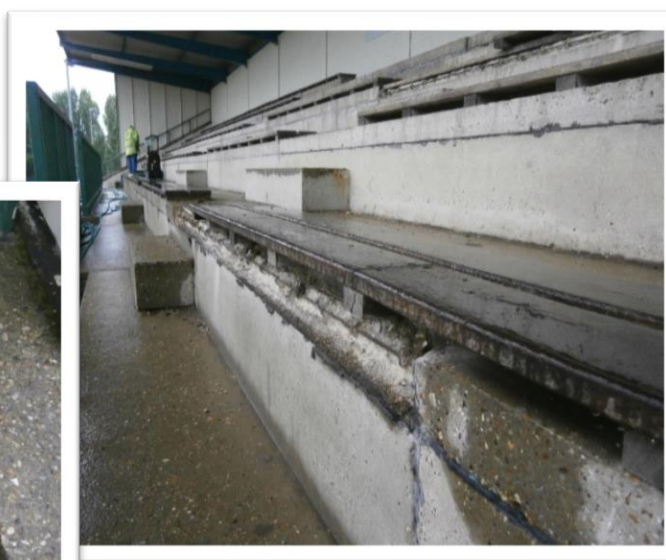
The solution: In January 2015, **APA** undertook a series of concrete defect surveys and testing to four reinforced concrete staircases, consisting of visual defect surveys, hammer surveys, cover surveys, carbonation testing and chloride profiling, with the aim of establishing the extent of the repairs required. The solution consisted of the removal of all delaminated, weak, damaged and deteriorated concrete, before cleaning the exposed rebar and reinstating the concrete using a Sika repair mortar, with galvanic anodes also being installed within the concrete repairs.

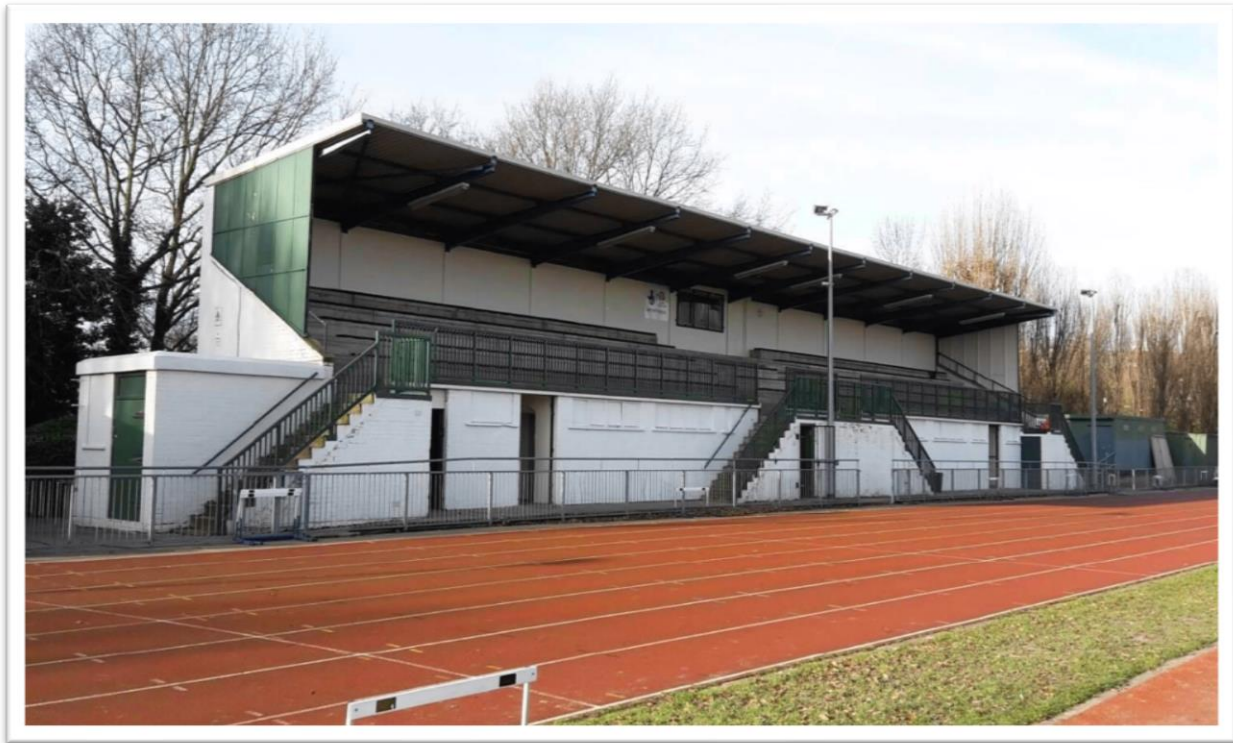
The outcome: The repair works undertaken to Wimbledon athletic stand were completed in August 2015 and resulted in the structural reinforcement and integrity of the four staircases which run through it. The galvanic anodes installed additionally provided the guarantee of prolonged protection against future corrosion, further increasing the life cycle of the repairs.
